Engineering Evaluation/Cost Analysis

**Non Time Critical Removal Support
Gulfco Marine Maintenance Superfund Site
906 Marlin Avenue
Freeport, Brazoria County, Texas
Contract No. EP-W-06-004
EPA Identification No. TXD055144539**

**U.S. Environmental Protection Agency
Region 6**

December 2010
Revision: 00
EA Project No. 14342.67

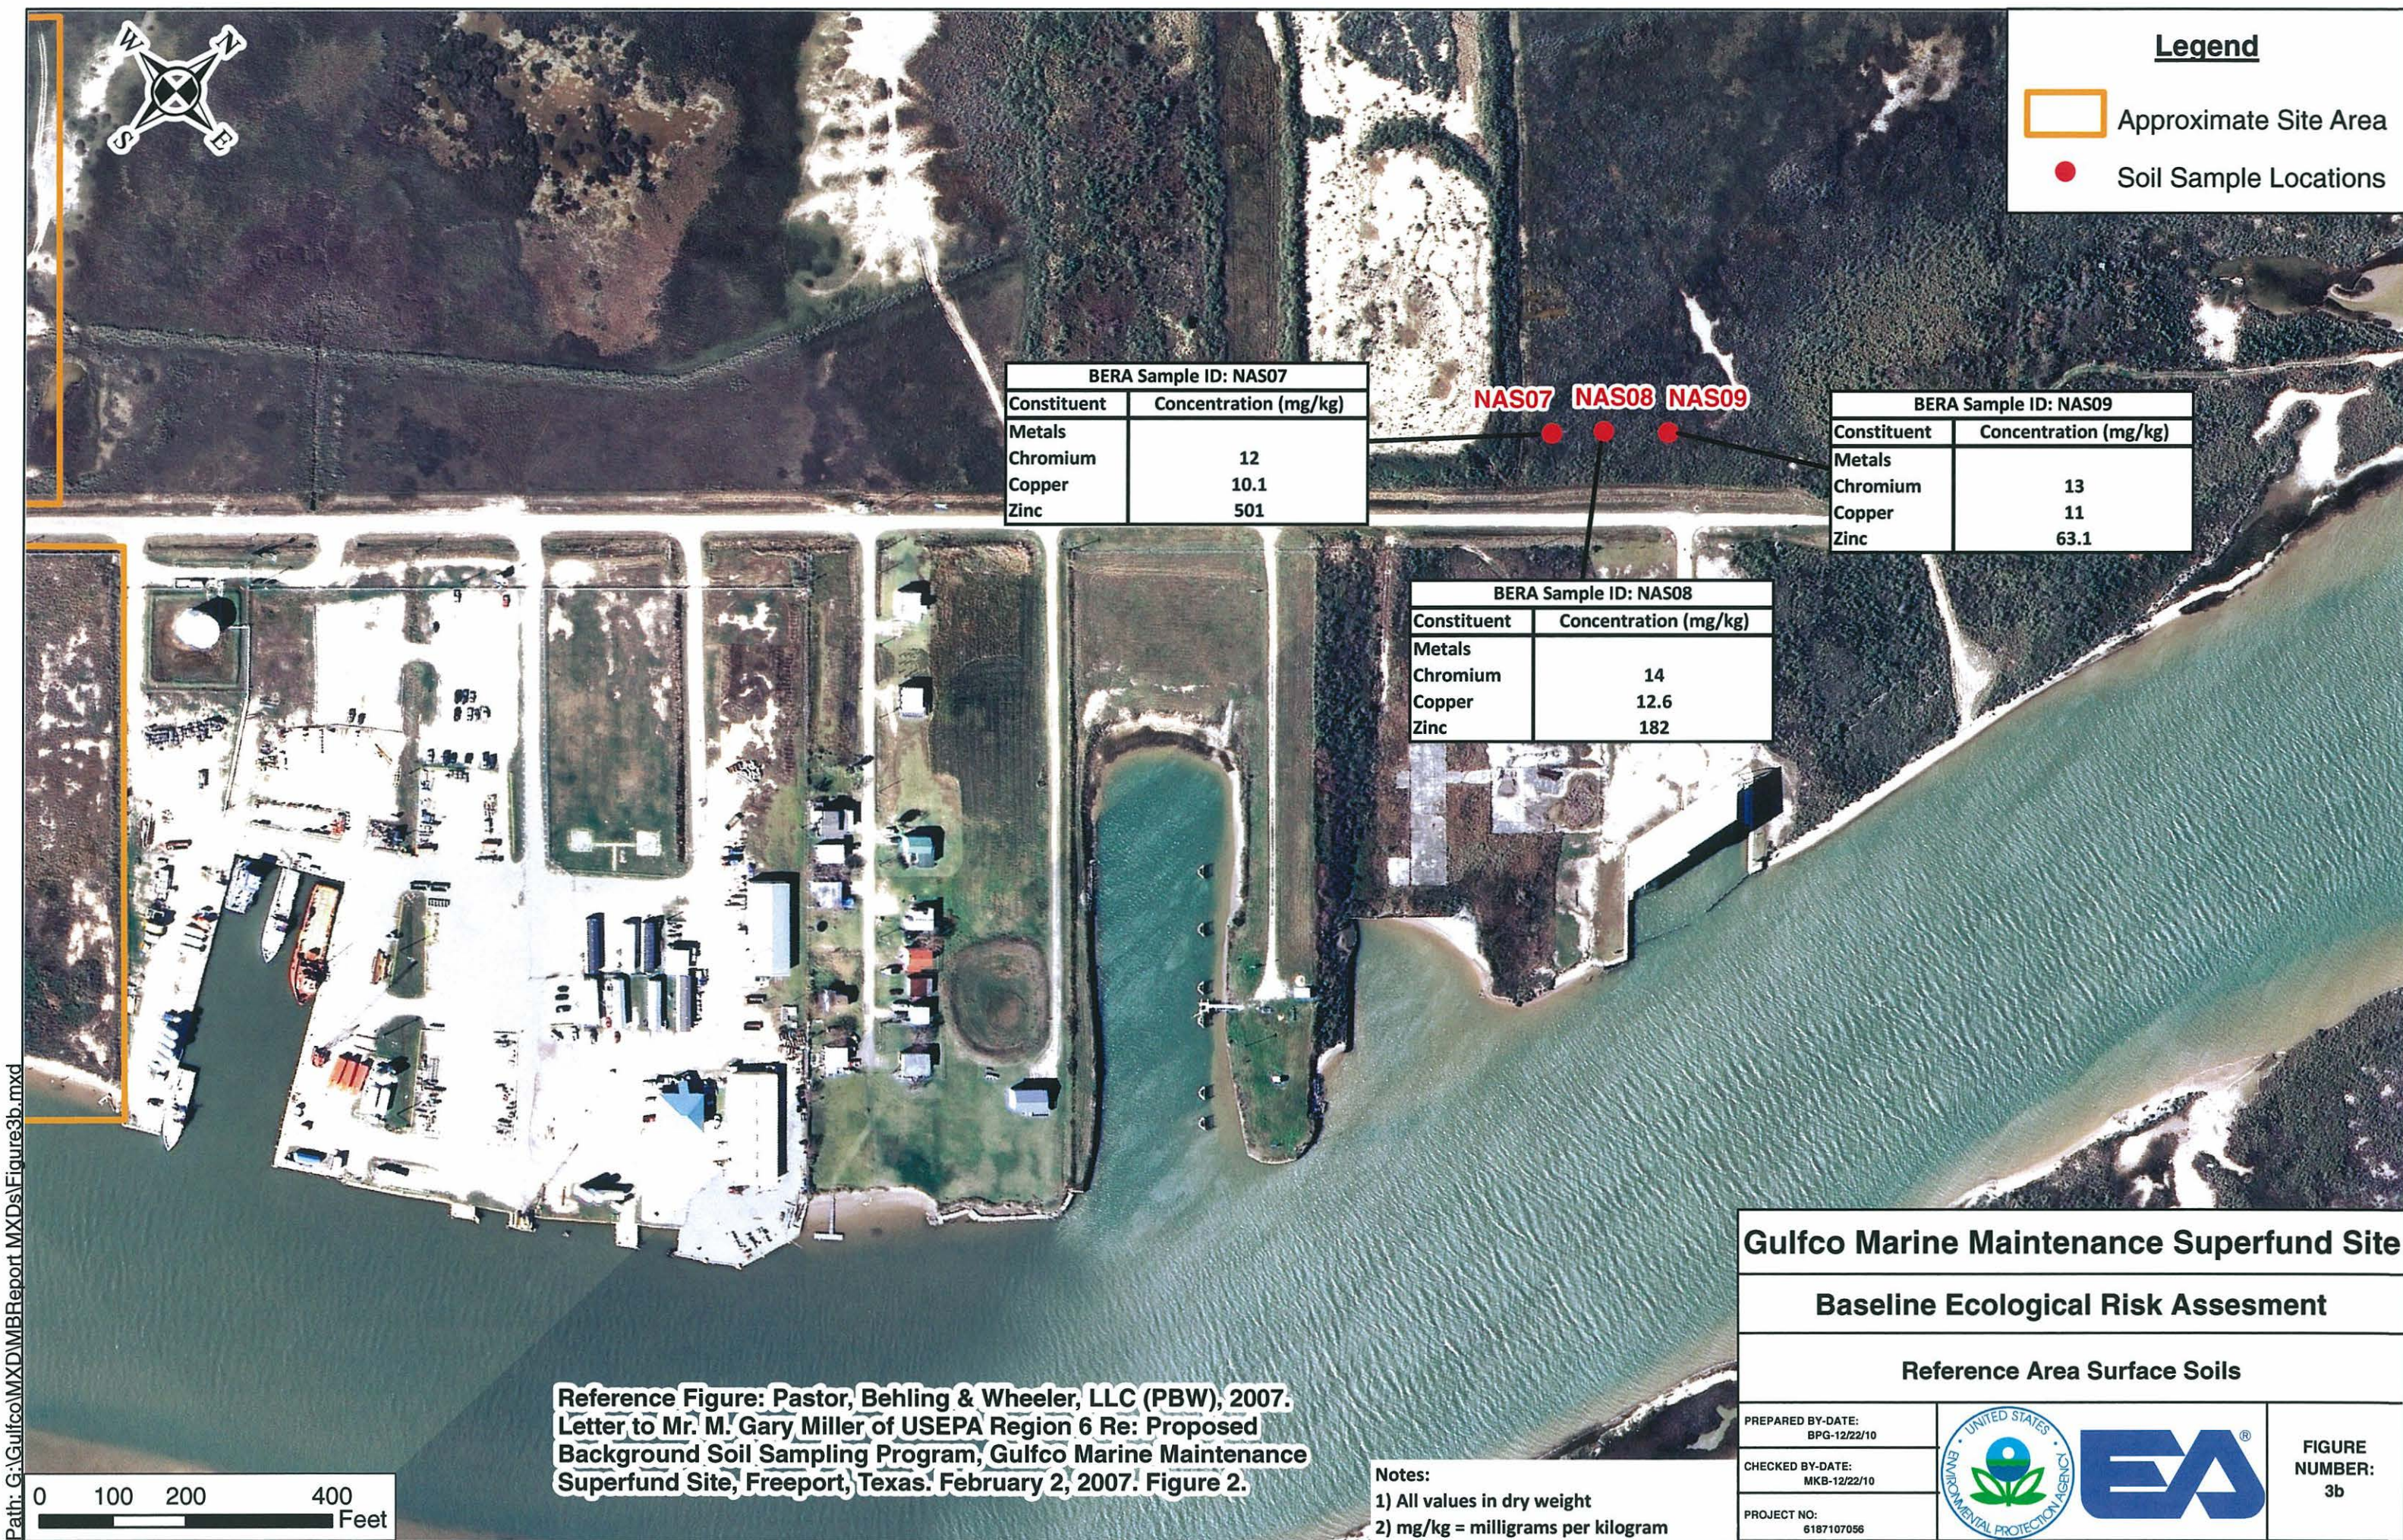
- Approximate Site Area
- Soil Sample Locations
